Massachusetts Department of Environmental Protection
Bureau of Resource Protection – Watershed Permitting Program
Sanitary Sewer Overflow (SSO)/Bypass
Notification Form

Hull, MA WPCF

Unauthorized Discharge Summary to Surface Waters 23 Meade Ave [2/17/21]

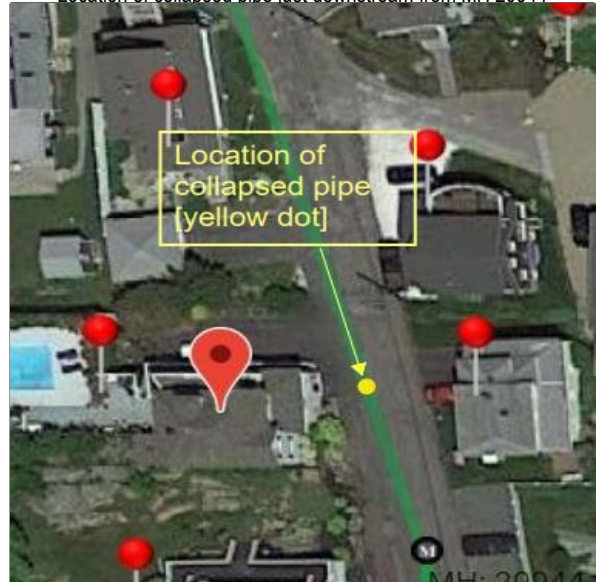
6. Cause of SSO Event: Pipe Collapse which then resulted in a blocked sewer line

Location of collapsed pipe just downstream from MH 20944

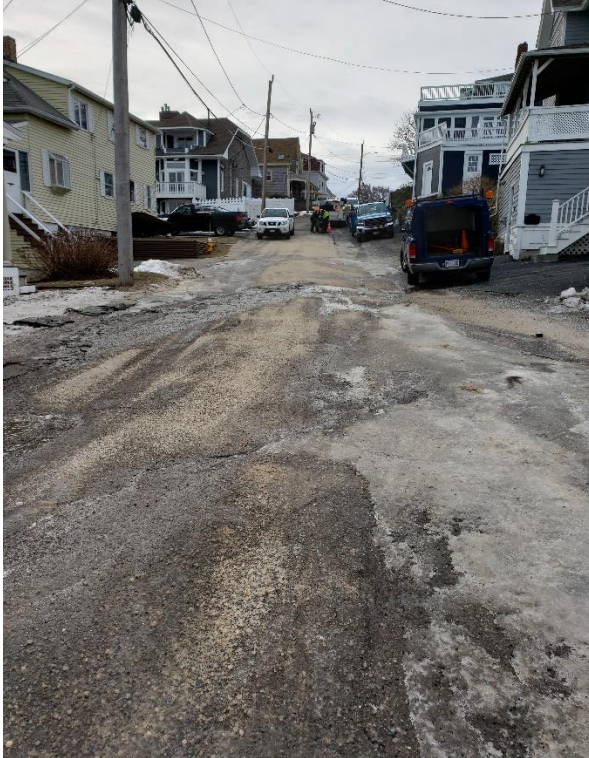
Diluted sewage broke through onto roadway surface and trickled/flowed down

Looking up Meade Ave [breakthrough seen in middle of picture]

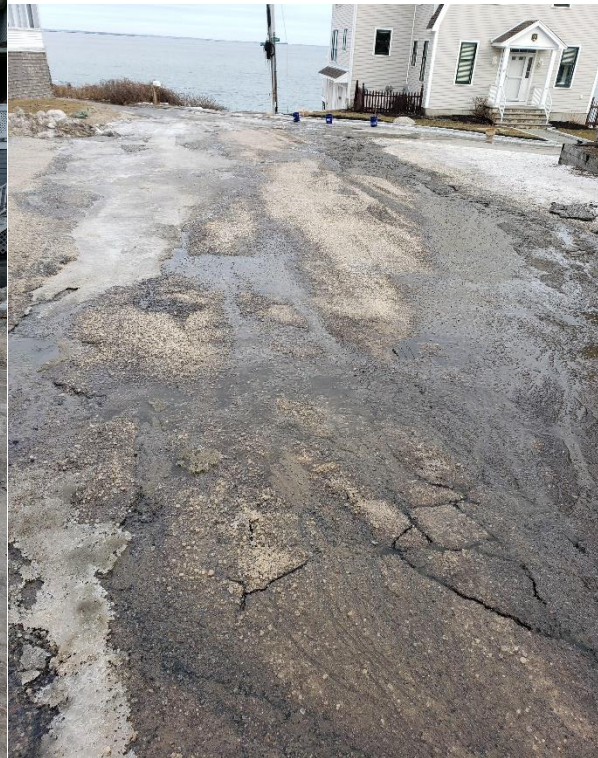
Looking down Meade Ave

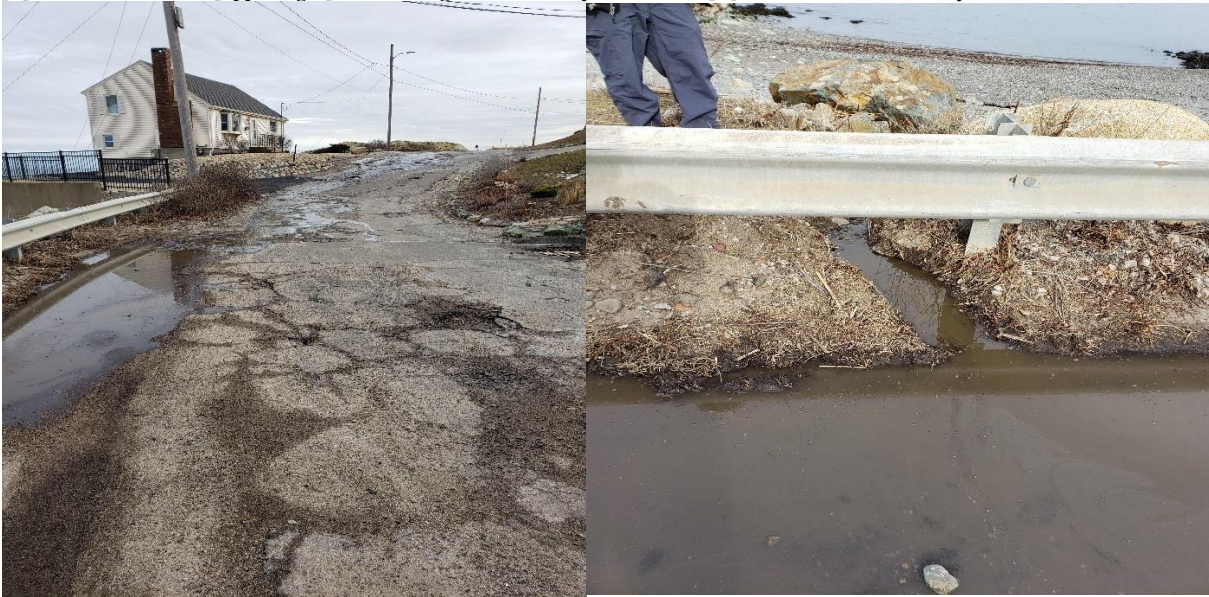
Did the release reach any portion of the Town's Municipal Separate Storm Sewer System ("MS4").	<i>No, release limited to asphalt surface and dried up in many areas, but there were pools of water along the roadway before reaching downstream catch basin. No catch basins in the immediate area.</i>
If the release occurred to the ground, provide the location of the nearest down-gradient catch	<i>Area is adjacent to Atlantic Ocean, and release flowed along the roadway and then ran into rocky</i>

[L] Base of Meade Ave [upper right] and heading towards Valley Beach Rd. [R] Side of the road & rocky embankment

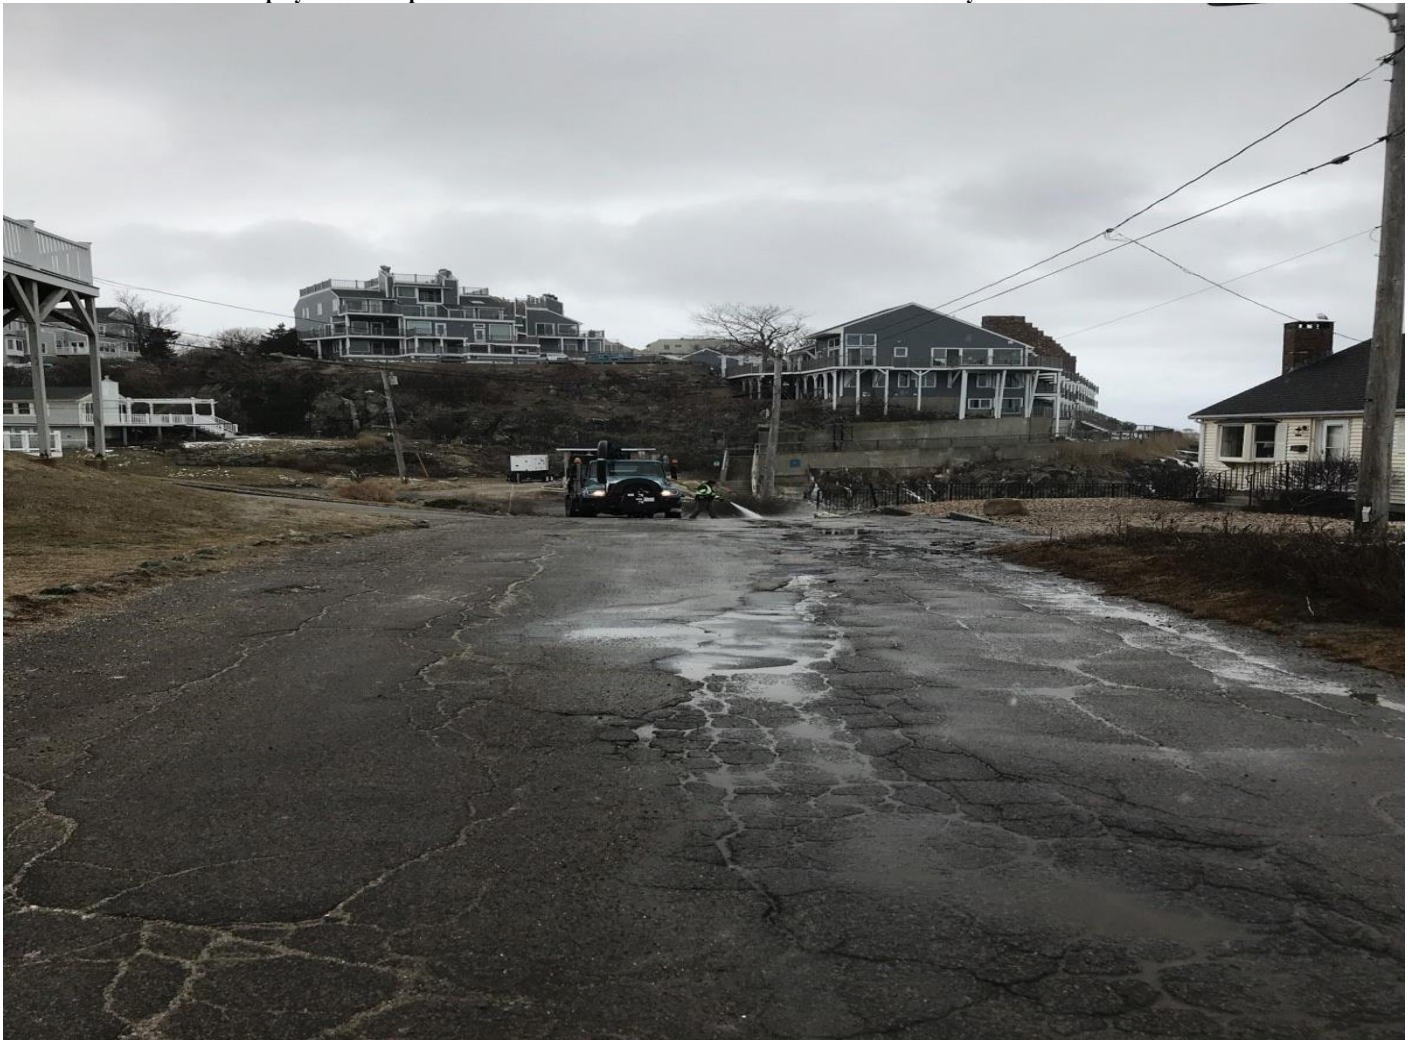
Clean up by Truax Corp. Lower end of Meade Ave towards Lift Station A and Valley Beach Rd.

Details: Area roadway surfaces washed down and liquid vacuumed up by vacuor truck.

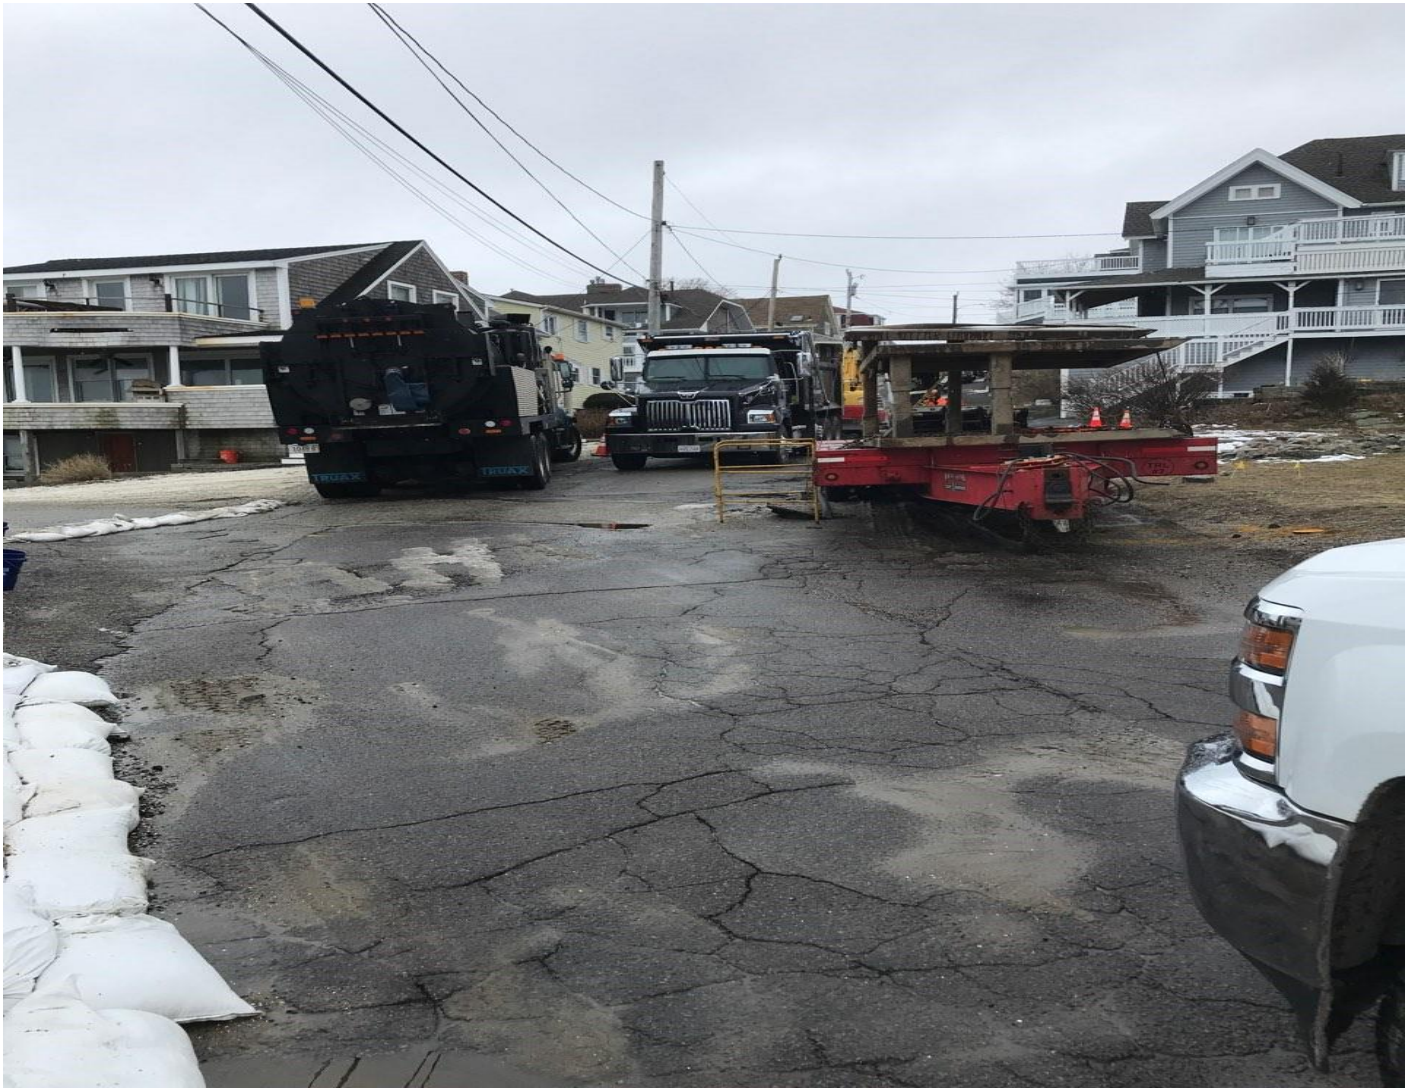
Aqualine Utility performing sewer pipe repairs [Roadway cleaned below area of work]

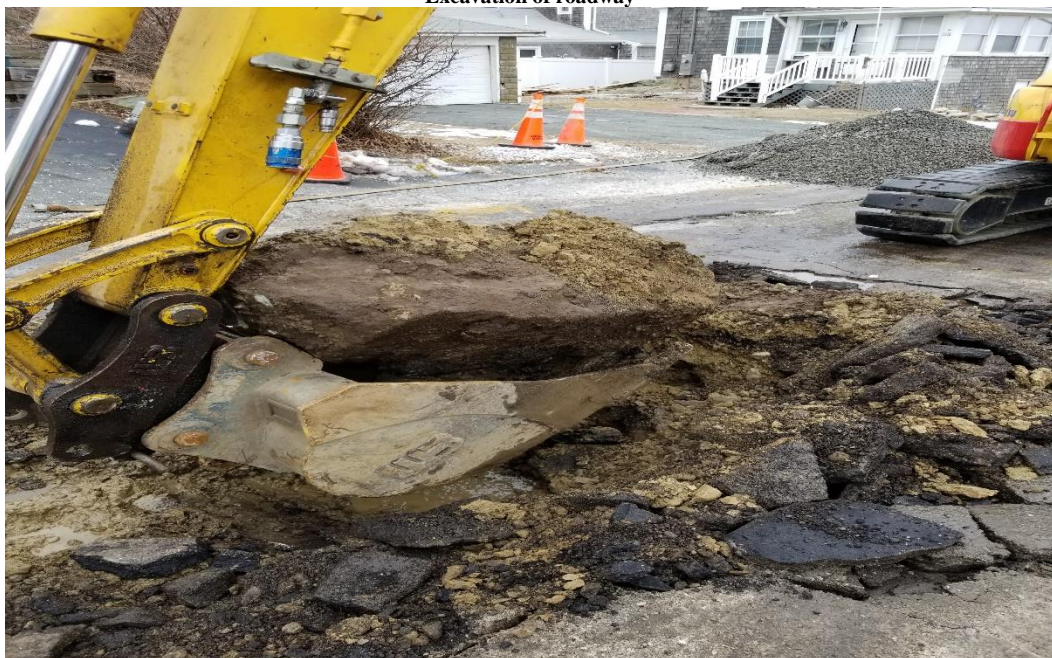
Excavation of roadway

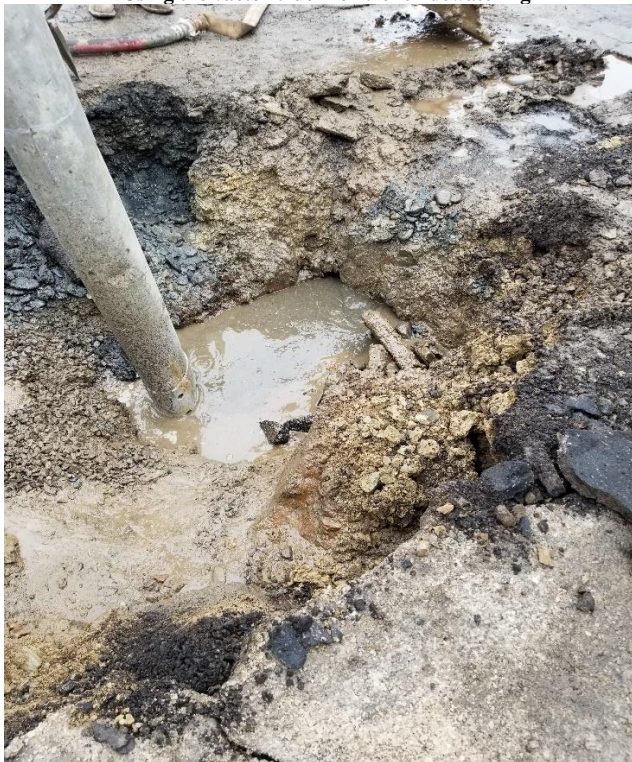
Using the vactor truck for trench dewatering

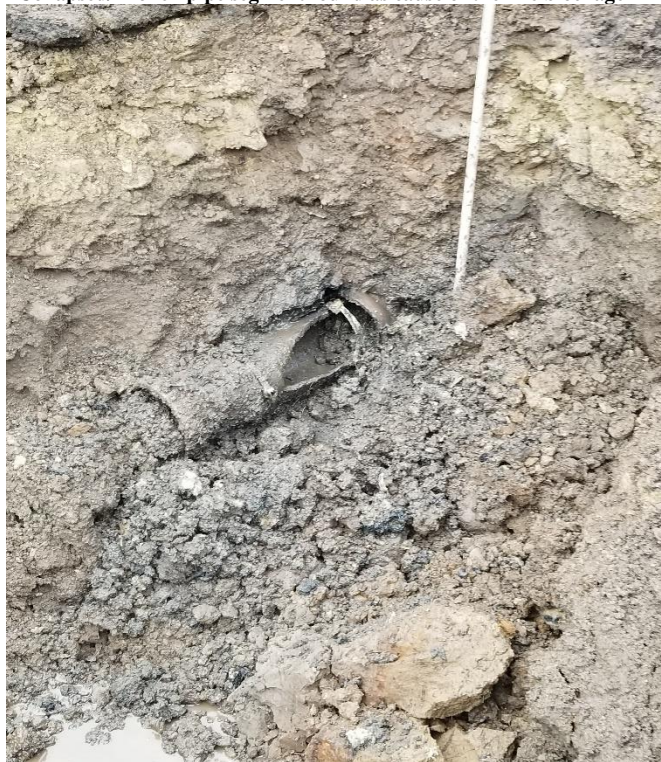
Collapsed/Broken pipe segment found as cause of the line blockage

Planned follow up action is to perform future additional CCTV of the piping downstream of the repaired area and
replace pipe as needed.
